Revision to First MTP Arthrodesis

Author: Julio C. Ortiz, DPM

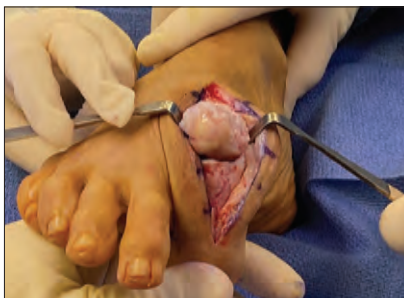
Upon visualization of the first MTP joint, small osteophytes were observed on the metatarsal head's dorsal aspect and removed with a sagittal saw. Denudation of 80% of the cartilage of the metatarsal head was also noted (**Figure 1**).

Figure 1. Exposure of metatarsal head

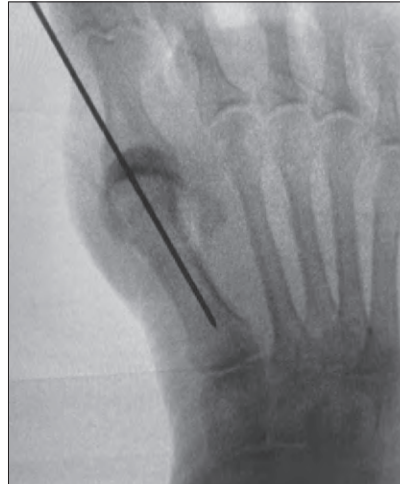
Figure 2. Fluoroscopic verification of guide wire trajectory

A 0.062" single trocar guide wire was inserted into the central aspect of the metatarsal head and into the diaphysis with the position verified under fluoroscopy (**Figure 2**).

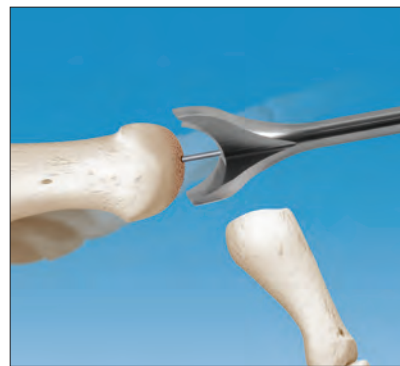
Figure 3. Reaming of metatarsal head

The CoLink 2 cone reamers were used sequentially, starting with the largest diameter, until bleeding cancellous bone was observed (**Figure 3**). The guide wire was removed and used to fenestrate the metatarsal head.

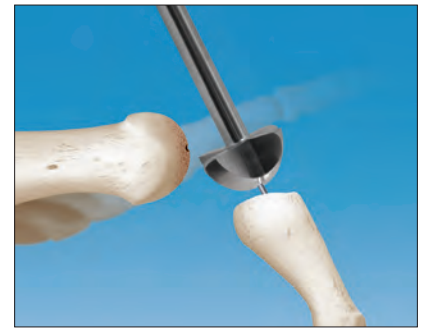
Figure 4. Reaming of proximal phalanx

The CoLink 2 cup reamers were used to ream until healthy cancellous bone was observed. Starting with the smallest diameter, reaming progressed until the cup reamer diameter matched the final cone reamer used

(**Figure 4**). The guide wire was removed and used to fenestrate the base of the proximal phalanx.

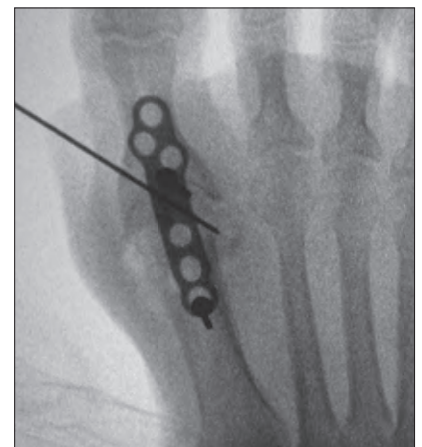
Figure 5. Temporary fixation of plate

After trialing with the CoLink 2 plate trials, a CoLink 2 MTP Plate was placed over the joint's dorsal aspect and temporary fixation was achieved with two olive wires (**Figure 5**).
